## Talbot Hotel, Preliminary Condition Survey of Exterior Masonry

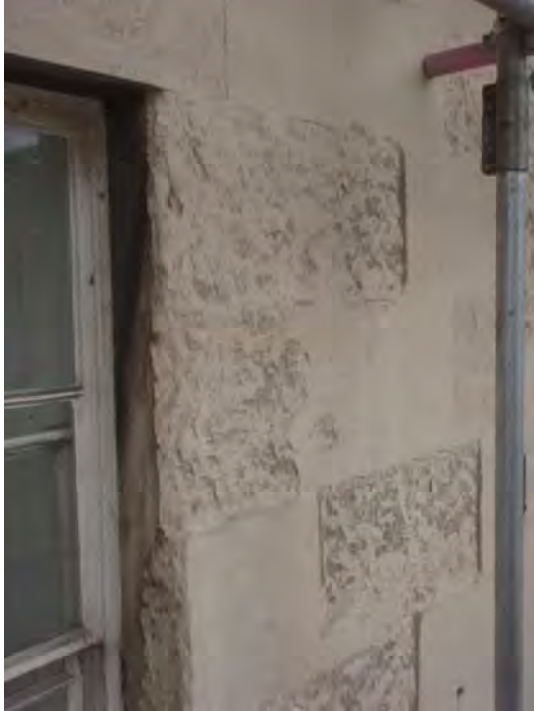
*erosion of face-bedded blocks*

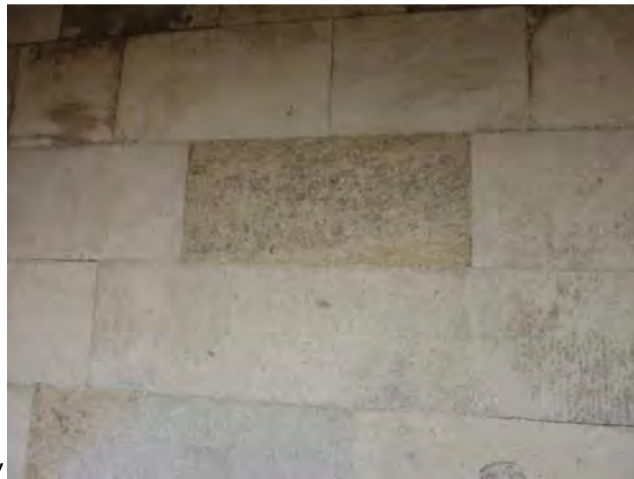
*oolitic limestone block amidst Hildenley*

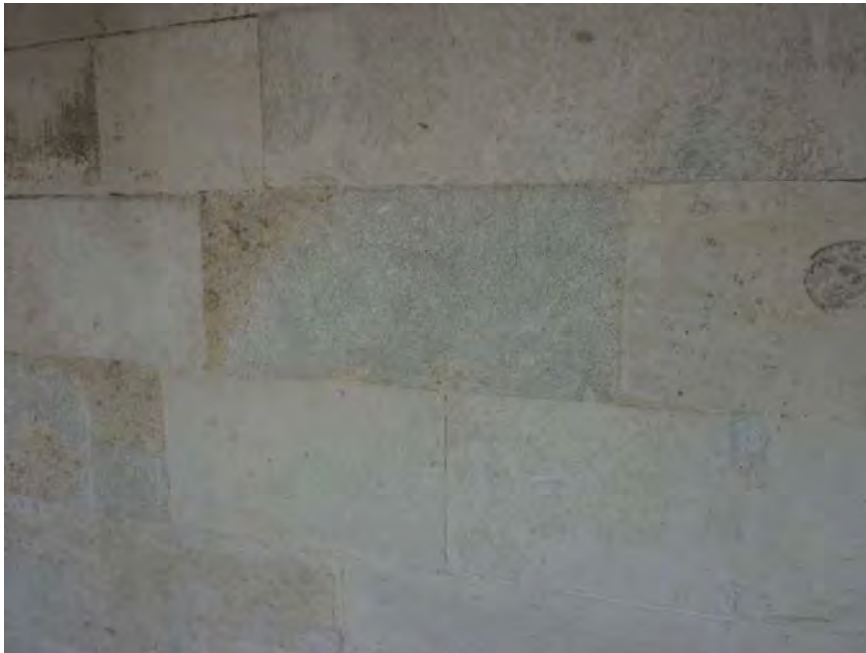
*Reasonably colour matched but cementitious render repairs to oolite blocks, 2<sup>nd</sup> floor, now loose.*

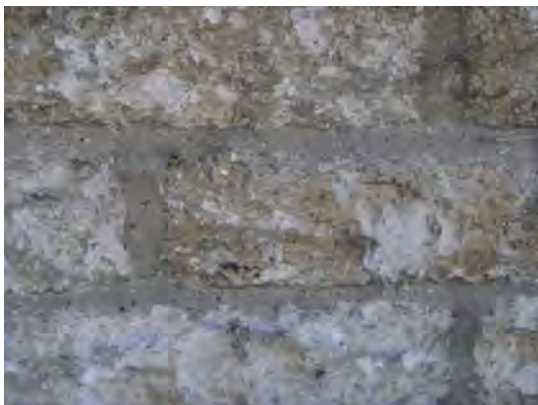
*Malton Oolite stonework beneath Hildenley limestone cornice (which will date from early C18 and have been raised with the building). Note remnants of copperas pigment to both cornice (above) and coursed rubble. Opc mortar.*

The second floor exterior is of malton oolite. It has been repointed in the past with opc mortar which has induced low level decay across this part of the elevation. There is delamination and powdering. The opc mortar should be removed and the whole elevation repointed with a soft, preferably hot lime mortar to match the original.

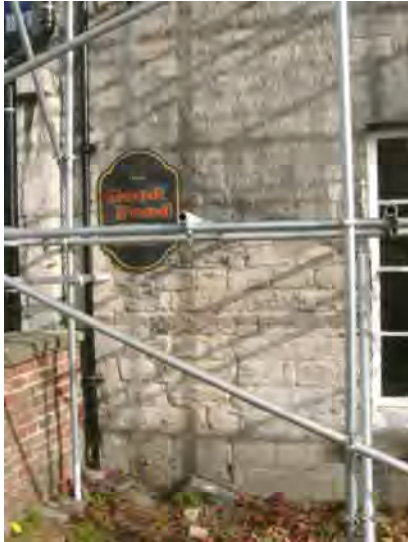
*trial panel of moderately sulphated stonework, June 2010.  
Uncleaned masonry above and around signage.*

As a whole, this elevation should be cleaned down with nebulous water sprays and bristle brushes/phosphor bronze or fine stainless steel brushes. The latter would assist removal of suckers without unduly abrading the masonry. A trial panel for this treatment was carried out to the lower l/h corner of this elevation in June 2010 as part of a stone cleaning CPD event.

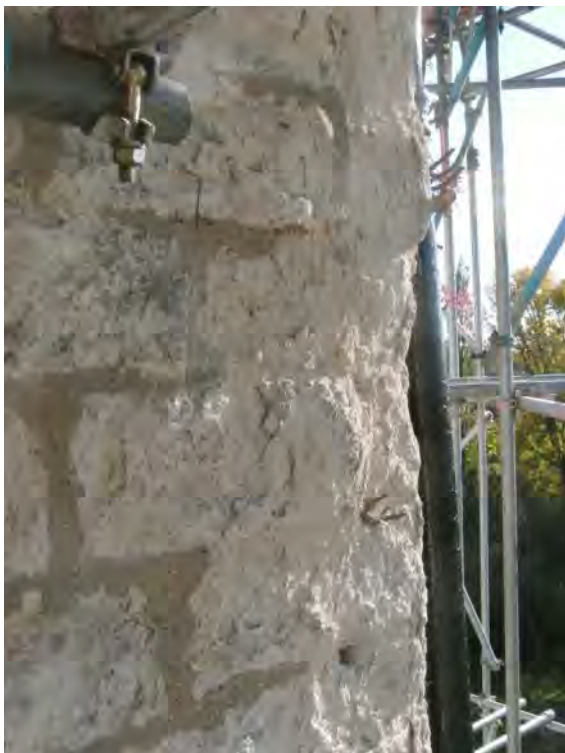
The southern quoin of this elevation is severely decayed at this level and will require replacement

This decay is entirely due to the proximity of these stones to the bay window on the south. More specifically, it is due to the opc mortars with which this bay window was rebuilt in recent times. Up to 20 quoin stones require replacement. Bed-heights are typically 5 ½; 6; 7; 8 inches. Replacement should be in oolitic limestone – Tetbury white bed.

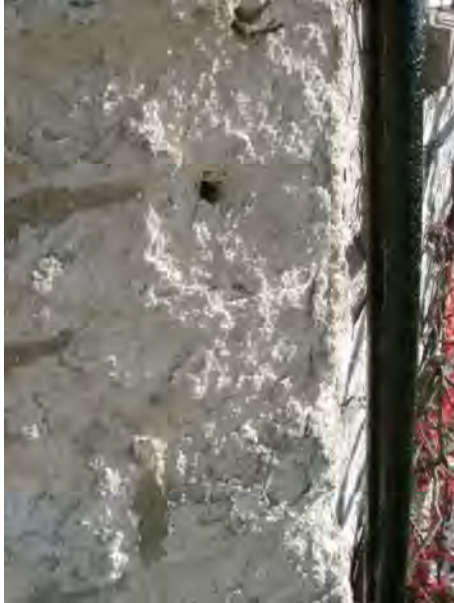
Two Hildenley limestone quoins at the N end may also be replaced. Only one could be safely measured: 22" x 5" x 9". Two stones of this dimension would suffice and these should be of Portland Base-bed.

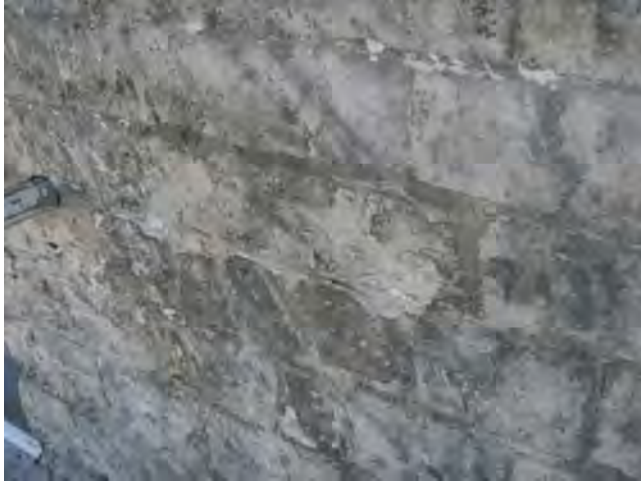
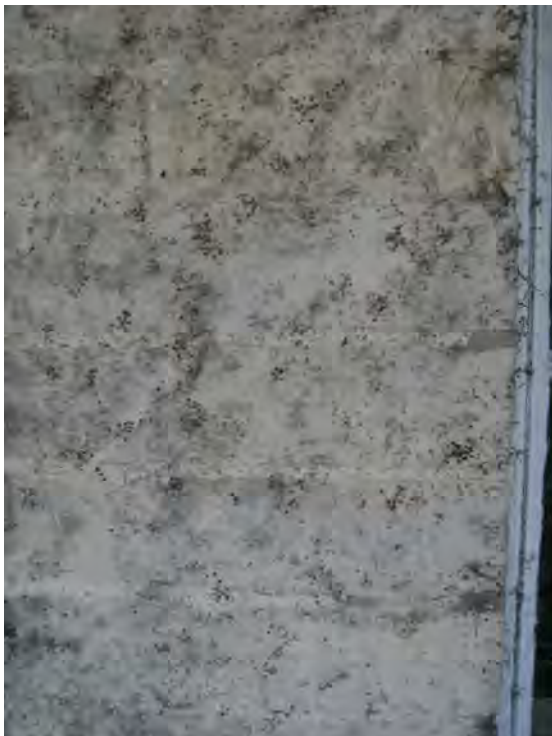
*Original lime mortars in excellent condition*

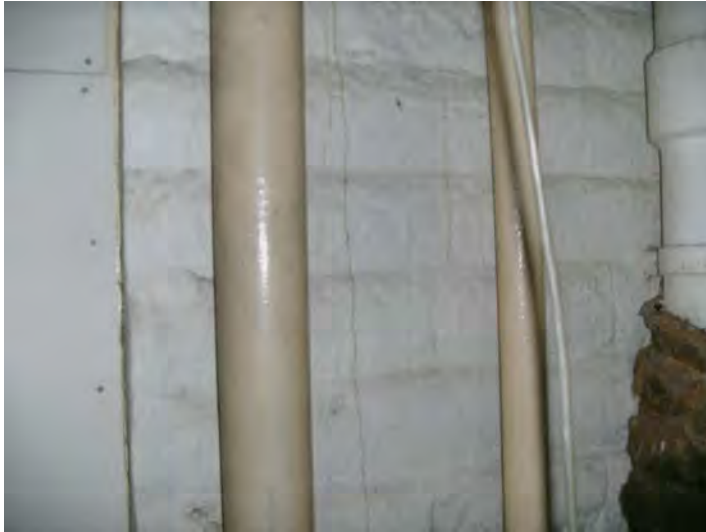
*South elevation of original central range within atrium formed by C19 additions, showing early limewash.*

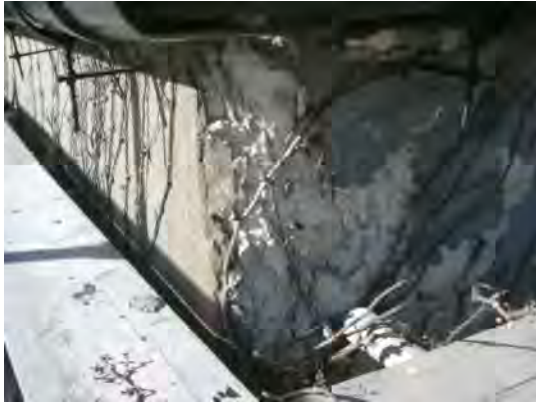
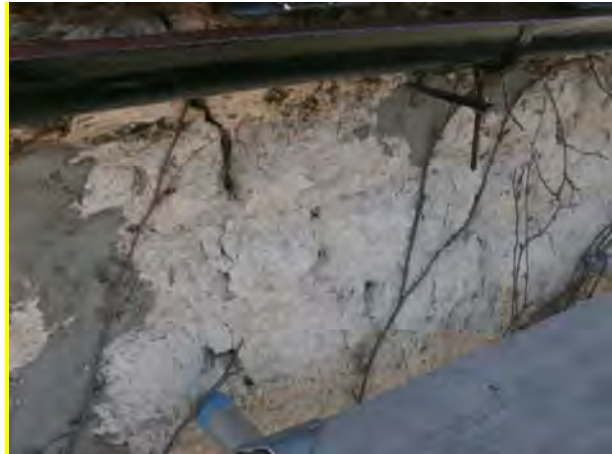
The south elevation of this is rendered with a cementitious mortar which remains largely intact, although it is cracked in some areas. This is incompatible with the softer oolitic limestone beneath and will loosen where it has not already done so. It will trap moisture within and promote decay of joist ends and other joinery that contacts the wall. This render should be removed but, as noted above, this is likely to reveal severely eroded and decayed oolitic limestone ashlar, which will require extensive consolidation and repair prior to limewashing or, perhaps, re-rendering with a soft lime mortar.

*South and east elevations of the addition, showing serious decay to oolite of east wall; opc render to south.*

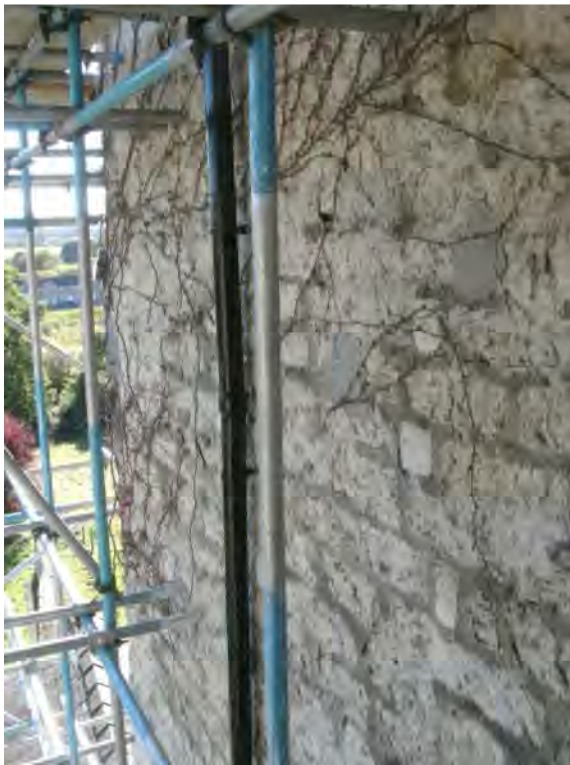
*lower east wall of same*

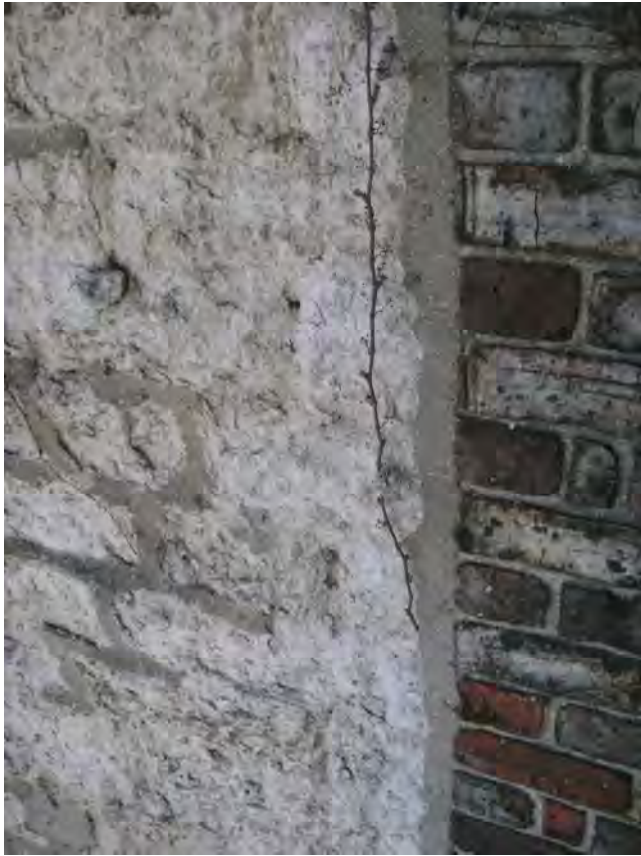
*junction of same with brickwork, early C19*

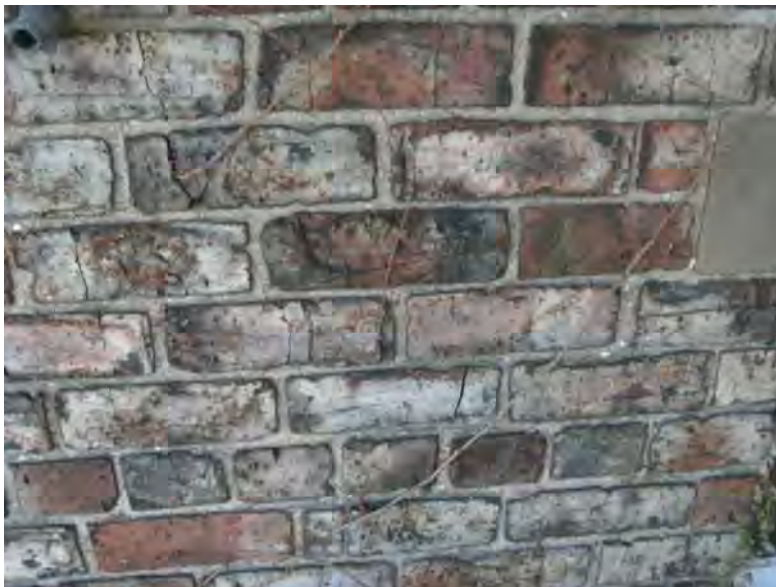
*Brickwork of C19 addition to east of above and to west of east range. Original lime pointing a little eroded back but sound.*

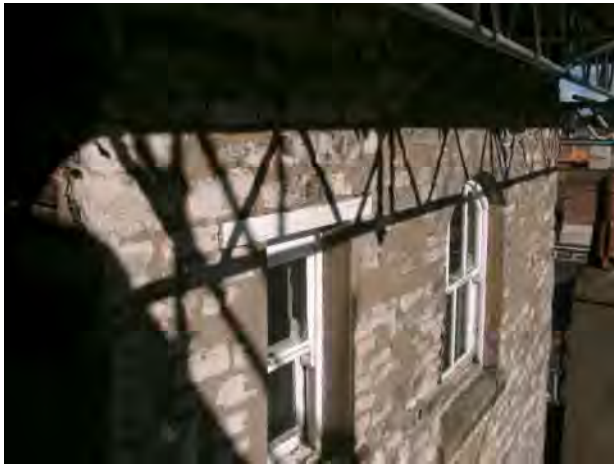
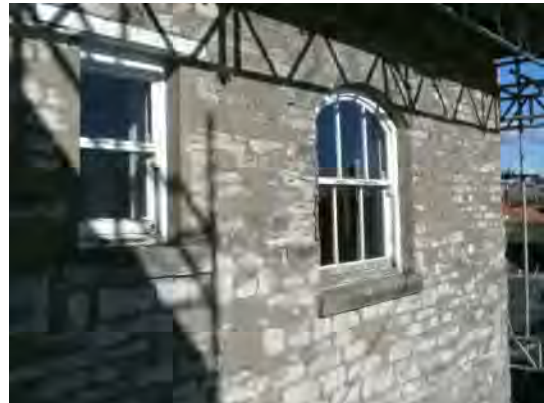
This is of Hildenley limestone but has suffered extensive repointing and localised render repair using OPC mortar. This has induced further decay. However, the method was not inappropriate and all OPC should be removed and replaced with lime mortar, either as repointing or as render repair of areas of cavernous decay. The stone, even where decayed, remains strong and essentially sound. The whole should then be limewashed as per the main elevations.

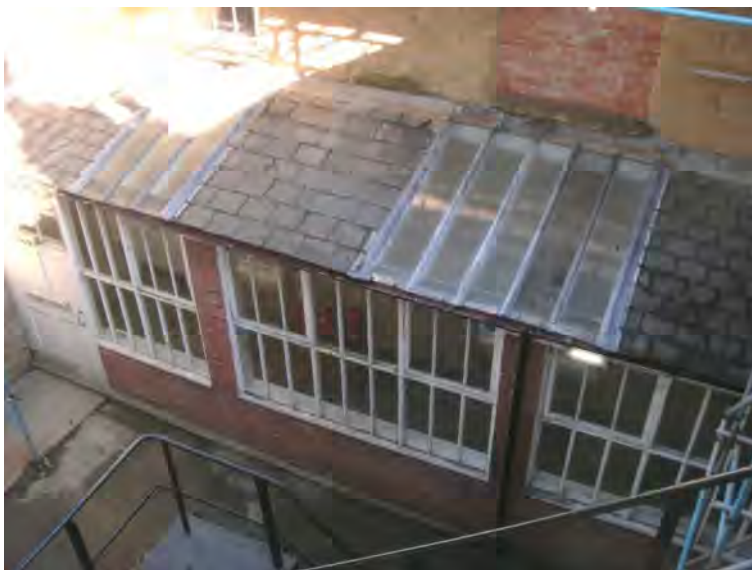
Above the west partly glazed passage to the west wall of the Cloisters, the calcareous sandstone elevation has been repointed with opc, which should be removed before repointing as necessary with lime mortar. The opc pointing is probably laid on, over perfectly and previously sound lime mortar, as was the fashion for some years within the Estate works department. Repointing of lime joints beneath may well not be necessary. These elevations were limewashed with a copperas pigmented wash in the past. One original sash window has been blocked with brick and there would seem no reason not to re-open this window were the courtyard to be improved and upgraded.

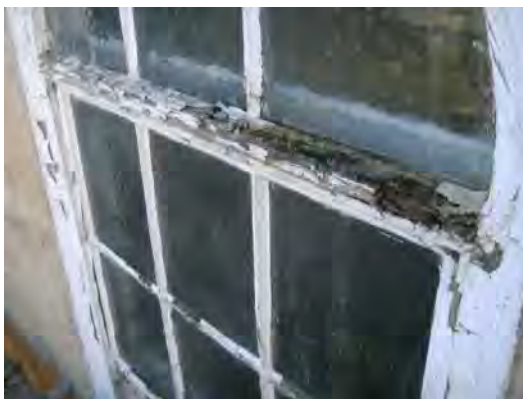
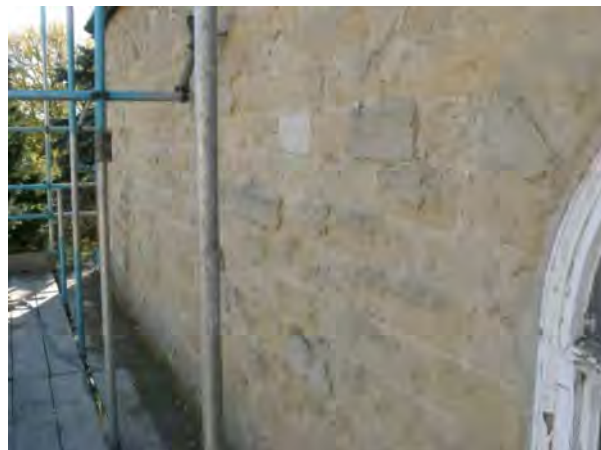
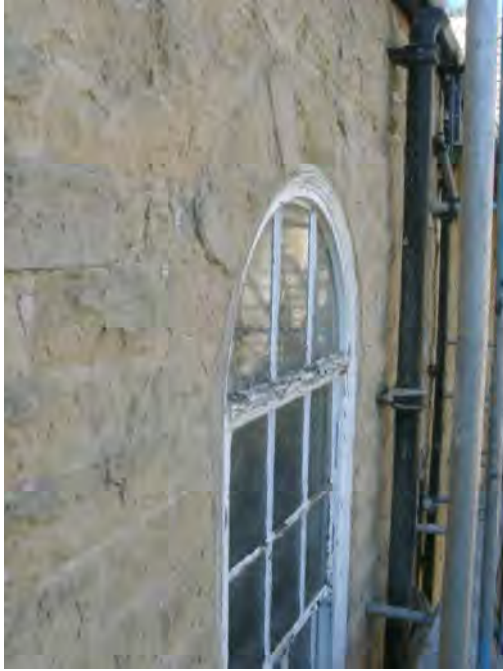
This elevation overlooks the yard of York House. It has suffered serious moisture penetration in parts due to defective rainwater goods, now repaired. Recent defrassing and localised repointing has greatly improved this elevation. The semi-circular sash window of the stair is seriously decayed and may need like-for-like replacement.

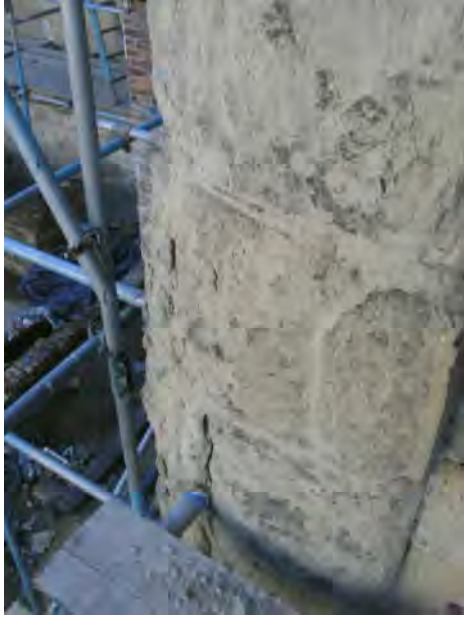
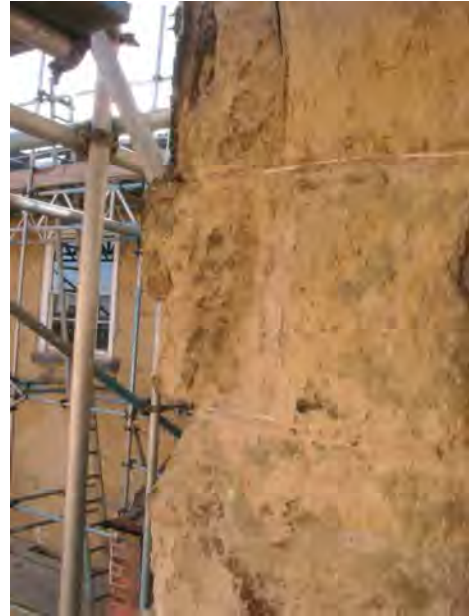
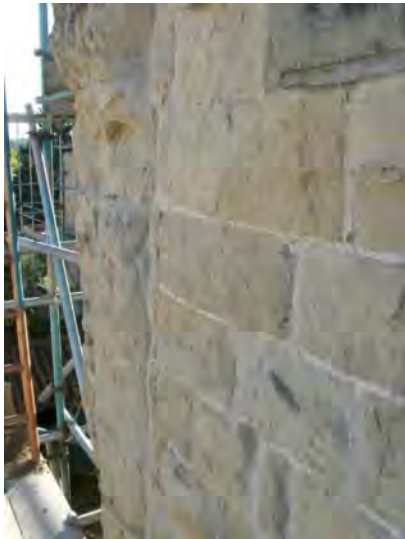
The east wall has suffered significant erosion but its appearance has been much improved by recent defrassing and repointing works. Two new cills, as well as a new string-course may be required.

There is significant erosion of the strip pilasters/south-east quoins at high level, though this is not yet structurally threatening. This wall may best be lime rendered, which would also conceal the unfortunate re-facing of the gable in the past with concrete blocks.
