Old Town Hall.

Malton Town Hall, 1728

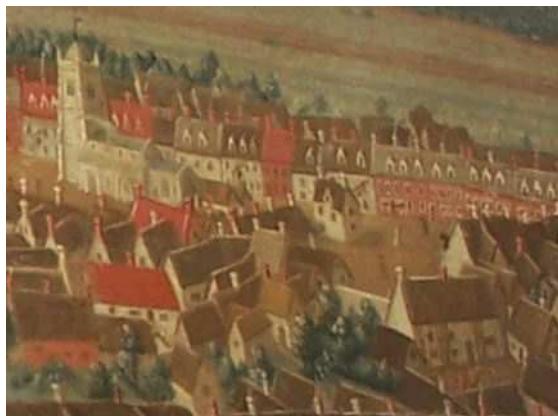
Malton Town Hall is said to date from the 16thC in its core. A vaulted and arcaded butter market was added to the core building seen on Settrington's 1728 painting of the town during the 18thC (and after 1728), with Council Chamber above.

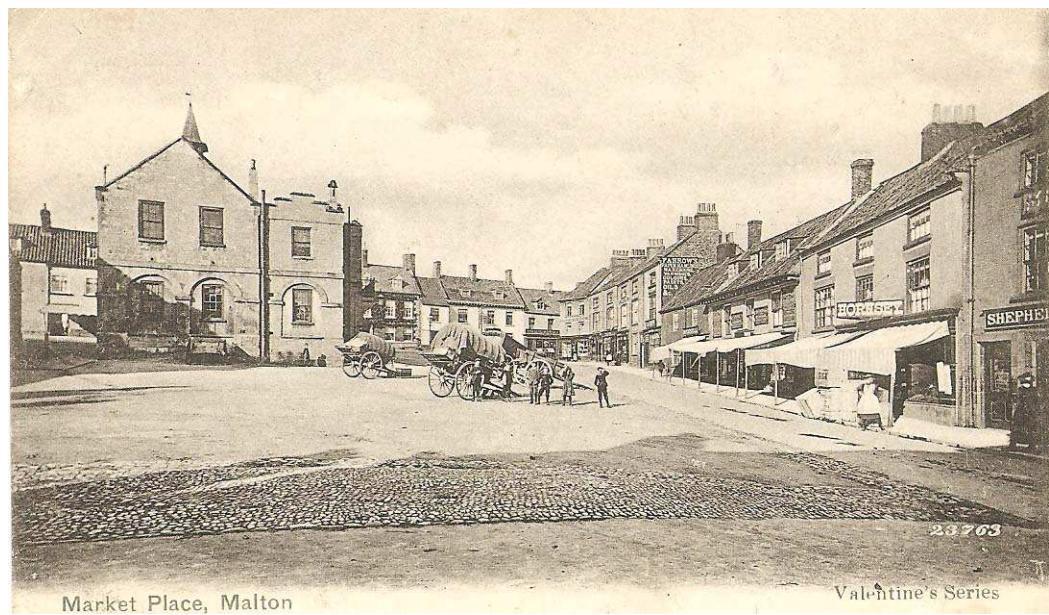
Market Place, Malton

The current entrance extension – to the east elevation – forms no part of the 1854 scheme: the balcony was recessed between two stepped gables and was accessed from the staircase. The current balcony and entrance are part of a relatively shallow eastward extension of the building. This is shown on photographs in John Stones’s *Around Malton*, from the late 19th and earlier 20th Centuries (p15), both of which pre-date the extensive introduction of west Yorkshire grit-stone to the south elevation, although by the time of the later image, some repair to the upper SE corner (also in west Yorkshire sandstone) has been carried out and remains today, the earlier calcareous sandstone ashlar having subsequently been rendered with a cementitious mortar, which is failing under the force of the decay it has promoted to the substrate.

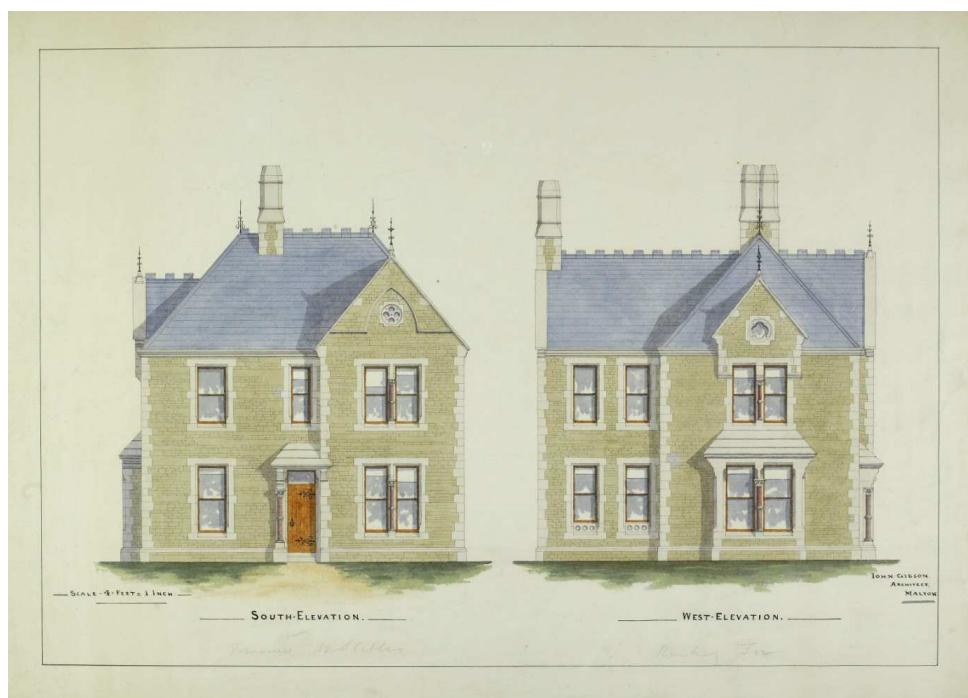
One of John Gibson's drawings for The Mount. This was built and remains today.
