## Talbot Hotel, Preliminary Condition Survey of Exterior Masonry

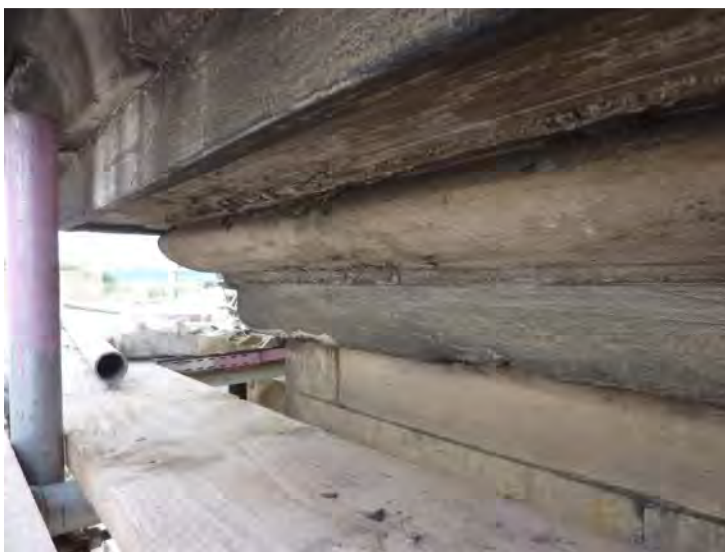
*lower part of cornice*

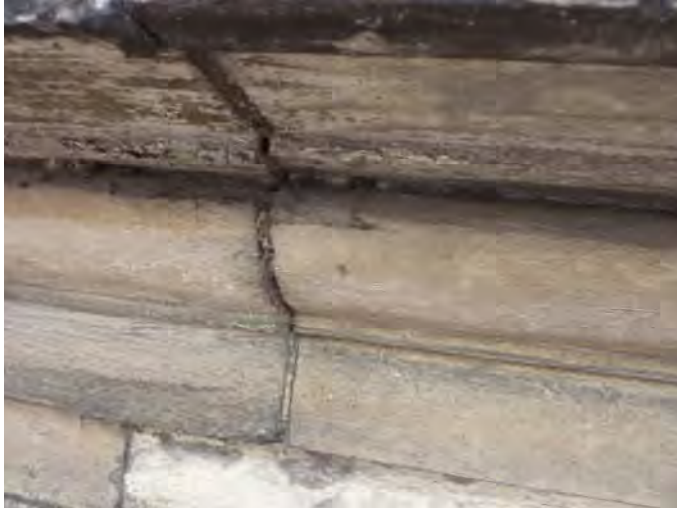
*French drag tooling on same*

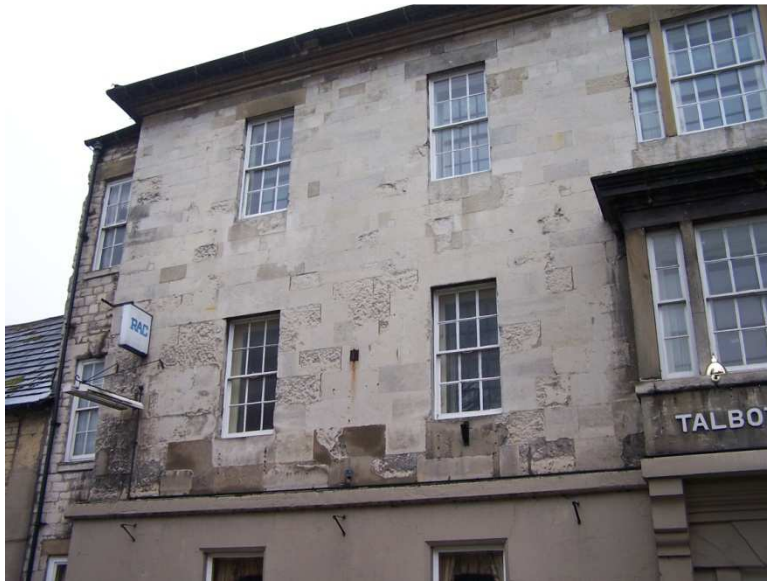
north elevation

The condition of the exterior masonry is generally good. There has been some erosion of face-bedded ashlar on the north elevation. Occasional blocks of oolitic limestone to the second floor have eroded somewhat more and some have been locally rendered with a cementitious (but white) facing. There has been no repointing with opc mortar and the original lime mortar is generally sound. Localised sulphation should be removed with nebulous sprays and bristle brushes.

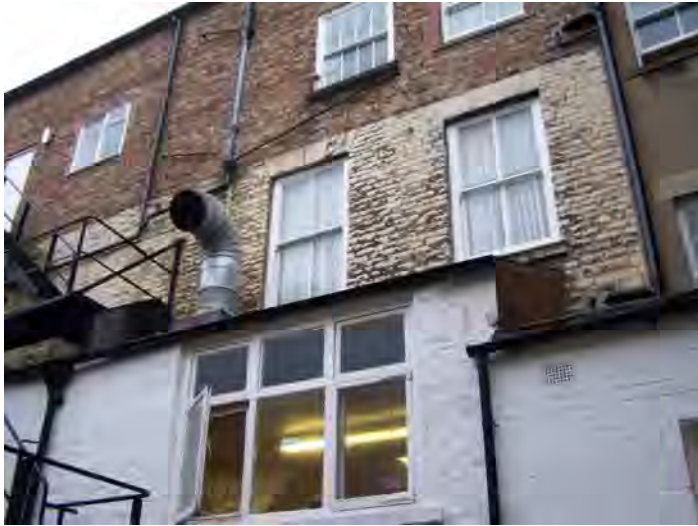
The east elevation has a 19thC addition of painted brick at courtyard level. The original dressed and coursed Hildenley limestone rubble has some sulphation staining and skinning which should be removed with nebulous water sprays and brushes. The brick of the raising is in a sound condition. Some localised repointing of the stonework may be necessary.

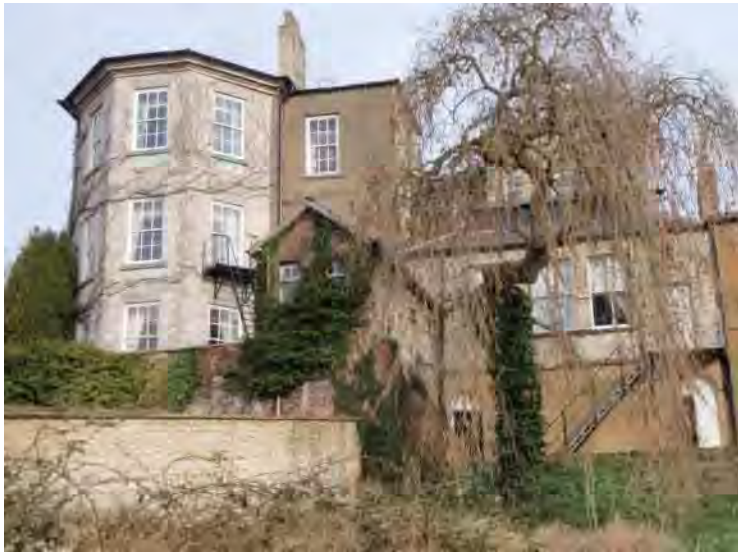
The south elevation of the east wing has suffered some localised opc render repair in the past. Much of this elevation is contained within later additions. The upper storey is available to the air and of mainly Hildenley limestone.

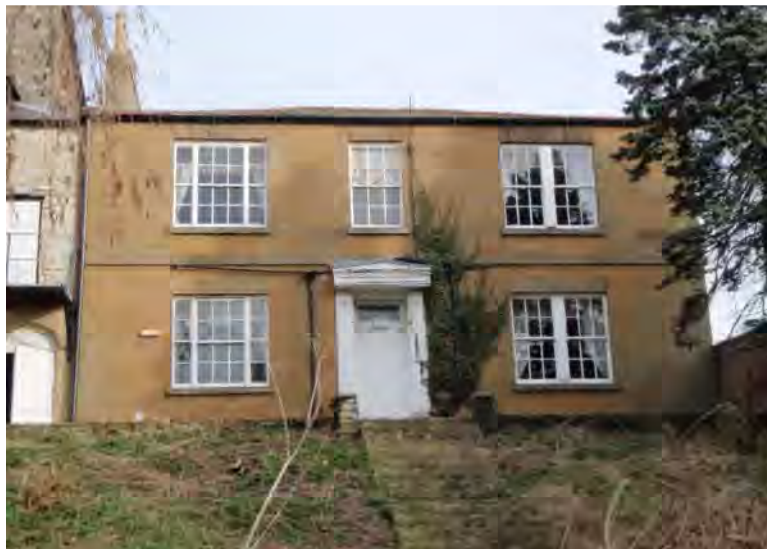
The Cloisters

Also of mainly calcareous sandstone is the 'Cloisters', a late Georgian villa built to the east of the hotel and to the south of number 43 in the early 19thC. The southern aspect has been refaced in a more siliceous, probably Jurassic sandstone in more recent times.

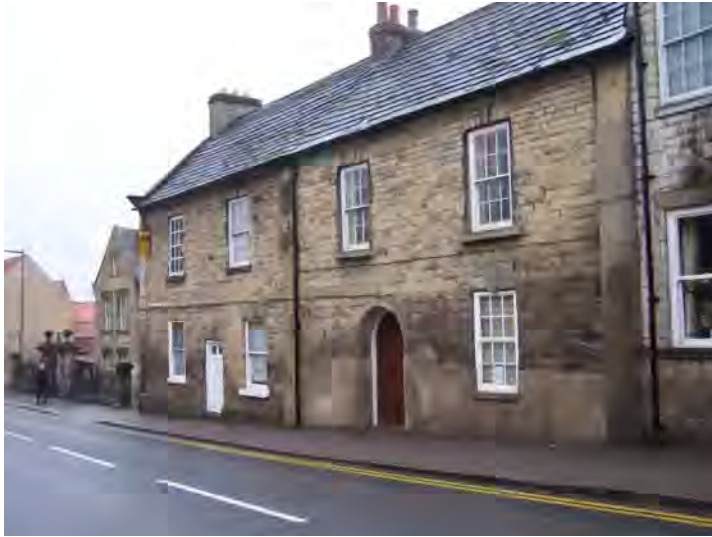
The condition of number 43 Yorkersgate is less happy than that of the hotel in general. Of calcareous sandstone ashlar between strip pilasters, this too would appear from the Settrington evidence, to have been raised a storey, probably around the same time as the main building, when the flat arched windows with raised and dropped keystones will have been introduced. Parts of the south elevation have been rendered with a hard cementitious mortar, although the colour is not displeasing. This building will require extensive repair and conservation in the future – string courses are severely compromised by decay and there is delamination of stone across much of the building. The east gable end was refaced with concrete blocks seeking to imitate pitch-faced ashlar. The whole should be relieved of all opc mortar and repointed as necessary. The stonework should be defrased with stiff bristle brushes and a gloved hand and cleaned down with water and brushes. Weathering and localised mortar repairs with some stone replacement – using stone from Brows quarry- should ideally be followed by limewashing. This should be distinct from any limewashing to the main hotel and from York House. A deep yellow ochre might be appropriate. The progressive degradation of the stonework will continue without such a treatment due to the heavy traffic flows along Yorkersgate. There is evidence within the courtyard to the south of this building and between it and the Cloisters of limewashing upon the calcareous sandstone of the latter – the pigment was copperas.

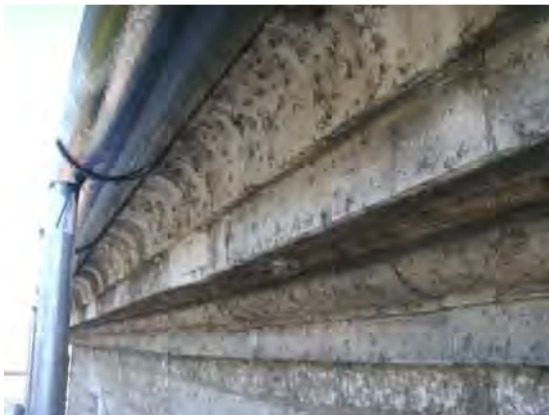
*cornice, matching that to N elevation*

Virginia Creeper suckers are tenacious, but every effort should be made to remove these in the future, though no scouring or heavy scraping of the stonework would be acceptable.

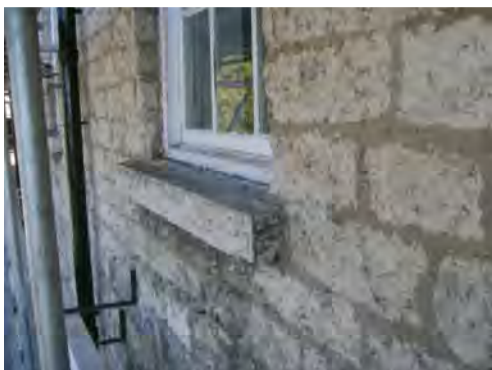
Window heads are of one stone, with false joints cut in to suggest multiple voussoirs. Heads and reveals are generally sound, but opc pointing around sash windows should be removed and repointing carried out in a soft, haired lime mortar.

As a whole, this elevation should be cleaned down with nebulous water sprays and bristle brushes/phosphor bronze or fine stainless steel brushes. The latter would assist removal of suckers without unduly abrading the masonry. A trial panel for this treatment was carried out to the lower l/h corner of this elevation in June 2010 as part of a stone cleaning CPD event.

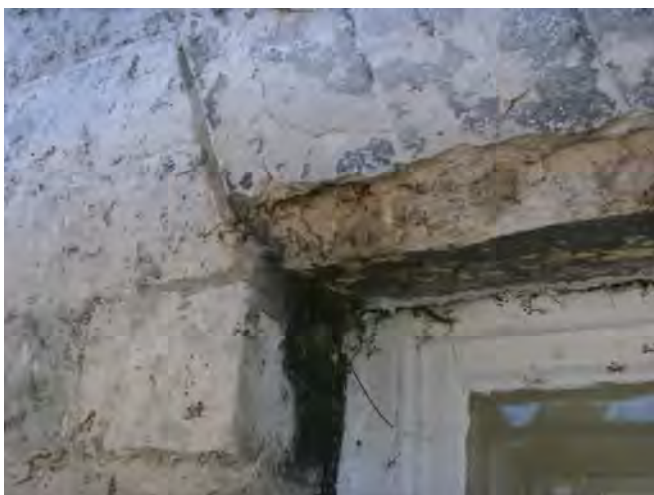
Across the whole elevation at this level, the Hildenley limestone is in pristine condition except where it abuts either the southern bay window or small areas of opc repointing. 95% of the wall at this level retains its original lime pointing and this is in a sound condition. The stonework will likely retain remnants of an off-white limewash which will facilitate the removal of soiling. Several Hildenley quoins at the S end are in decay due to the proximity of the opc rebuilt bay, but could not be safely measured. One head is suffering delamination due to opc repointing around it, but this may be mortar repaired after removal of the opc and the decay represents no structural concern.

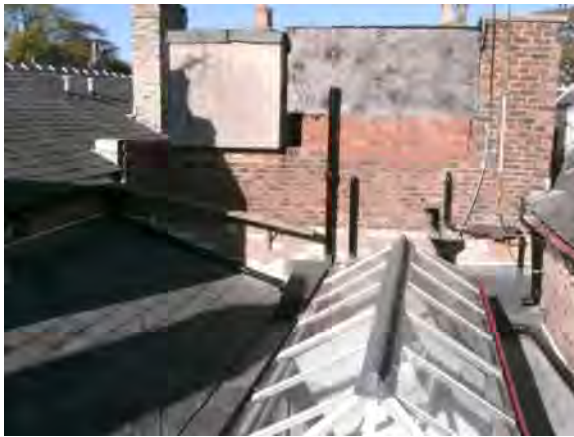
There is a jumble of walls at the various historic junctions of original building and additions, and an obtrusive brick wall which supports two water tanks. This wall sits upon the mid-C18 raising of the original south wall of the central range of the Strickland building, which was of stone. The raisings of the east and west ranges are of brick which has been repointed in the past with opc mortar. Ideally, this would be removed and the walls repointed in lime mortar. The opc is not causing any obvious decay to the brickwork, but will promote dampness within the wall and decay of timbers lodged within, including the truss ends. The stonework of the south wall of the central range that rises above the flat roof has been blathered with opc mortar and this should be removed and lime mortar reintroduced.

The aspect of the attic room of the East range would be greatly improved by the removal/relocation of the water tanks and the dismantlement of this wall. A dormer window in this attic space looks out onto the roof and this attic has potential as a hotel suite.

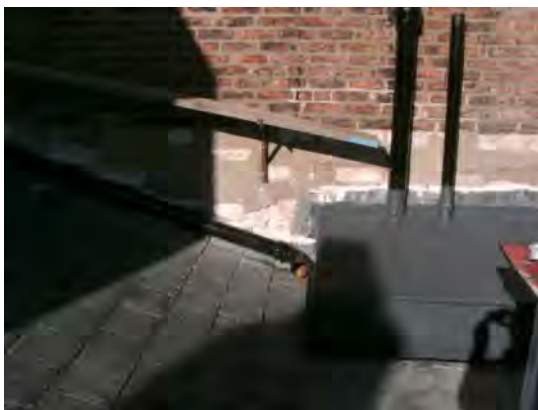
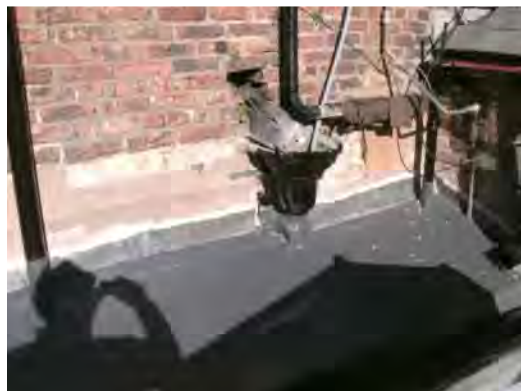
To the immediate south of this wall, there is a covered glazed roof of the atrium. There is an old iron hopper taking water from the north side of this wall.

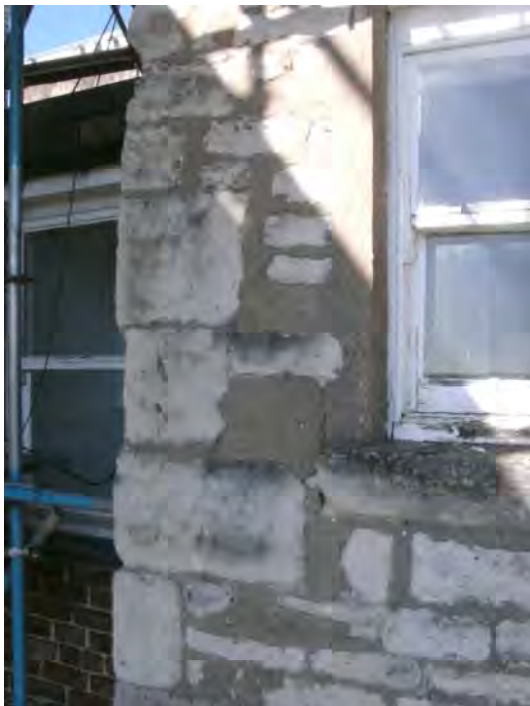
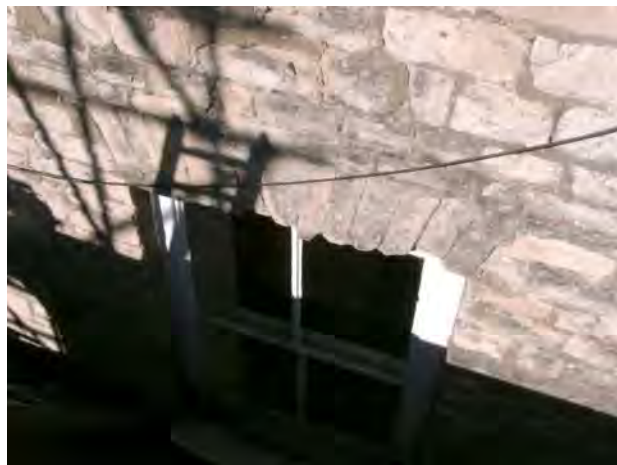
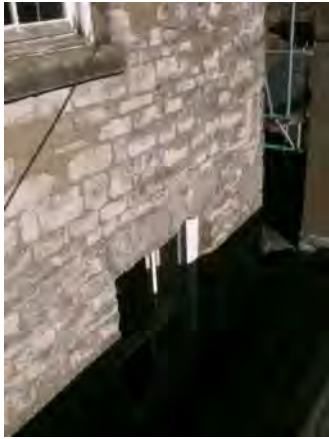
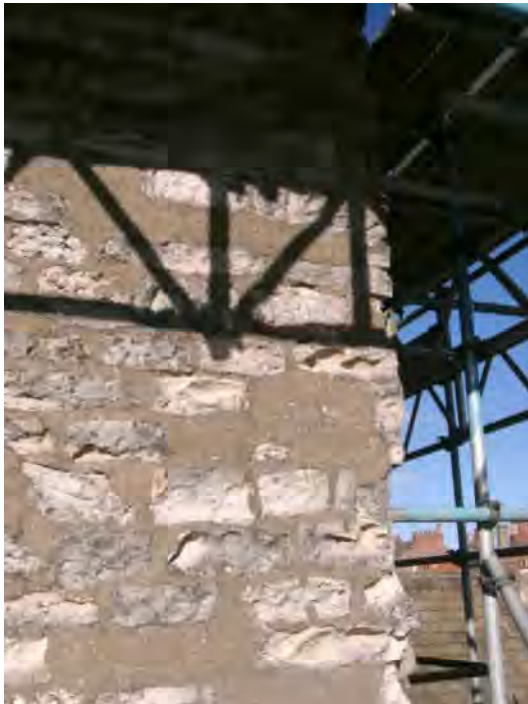
This is of Hildenley limestone but has suffered extensive repointing and localised render repair using OPC mortar. This has induced further decay. However, the method was not inappropriate and all OPC should be removed and replaced with lime mortar, either as repointing or as render repair of areas of cavernous decay. The stone, even where decayed, remains strong and essentially sound. The whole should then be limewashed as per the main elevations.

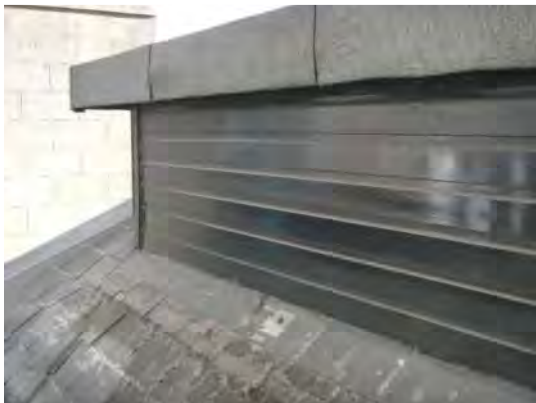
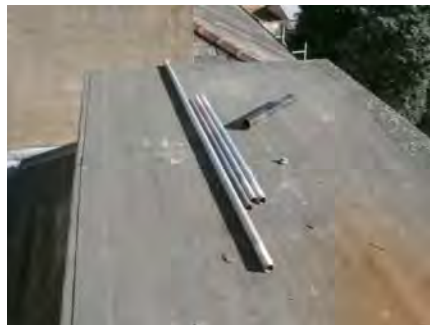
The ground floor level of this elevation is covered by the mid C19 addition of the function room, which abuts it; the first floor levels are obscured by the roof of this function room which has a remnant atrium/roof-light above.

A tongue and groove wall rises from the roof and has an asphalt sheet covered boxing of dubious structural integrity over. The aspect from the bedroom of the east wing would be much improved by the removal of this boxing to be replaced with roof slates, or by the reinstatement of the glazing.

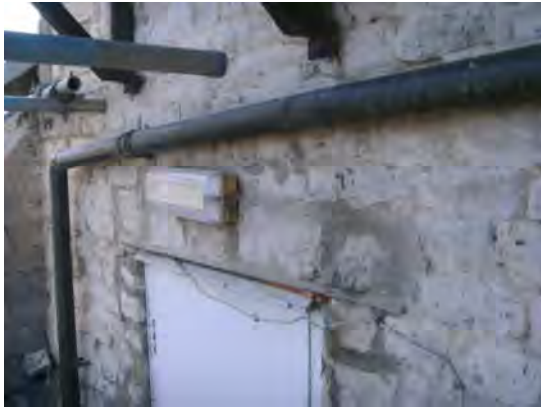
The Hildenley limestone of the first floor elevation retains its original lime mortar, though this has suffered some attrition. Some repointing will be required. Most of the ground floor of this elevation is covered by a C19 addition, though within arches at the base of this and to the S of it, early semi-circular windows remain visible, though blocked.

There has been localised repointing with opc, some of it associated with the introduction of a fire escape at the S end of the wall at first floor level. The iron fire escape descends into the courtyard formed by the Cloisters, 43 Yorkersgate and the East Range of the Strickland house.

Removal of the C19 addition and of the fire escape would immeasurably improve the aspect, attraction and usefulness of this courtyard and link it once more to the south terrace and garden of the Cloisters.

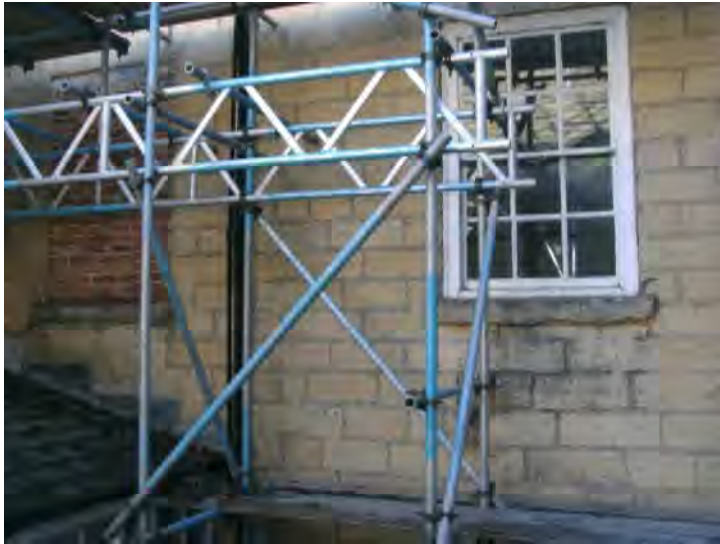
Above the west partly glazed passage to the west wall of the Cloisters, the calcareous sandstone elevation has been repointed with opc, which should be removed before repointing as necessary with lime mortar. The opc pointing is probably laid on, over perfectly and previously sound lime mortar, as was the fashion for some years within the Estate works department. Repointing of lime joints beneath may well not be necessary. These elevations were limewashed with a copperas pigmented wash in the past. One original sash window has been blocked with brick and there would seem no reason not to re-open this window were the courtyard to be improved and upgraded.

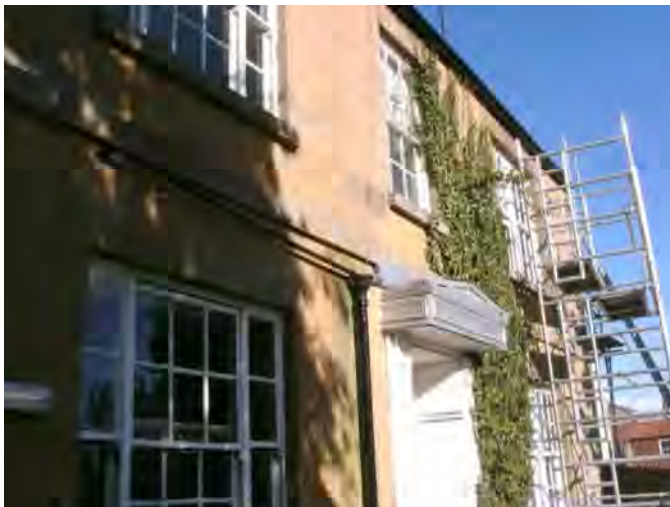
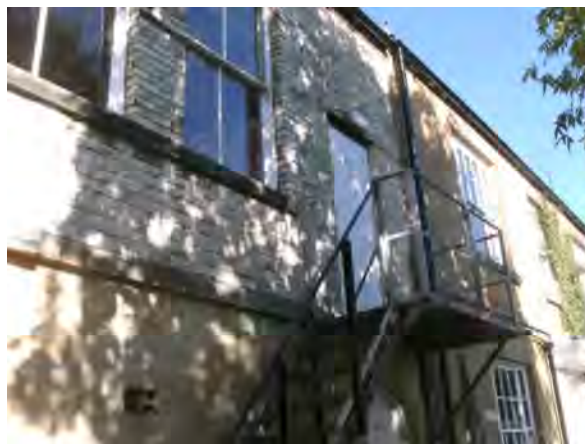
The south wall of the Cloisters was refaced in the past with a cladding of North York Moors sandstone. It has tight joints, some of which have lost their lime mortar. This elevation should be repointed as necessary.

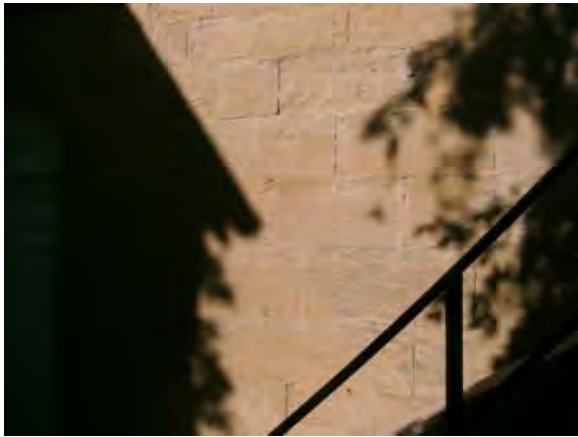
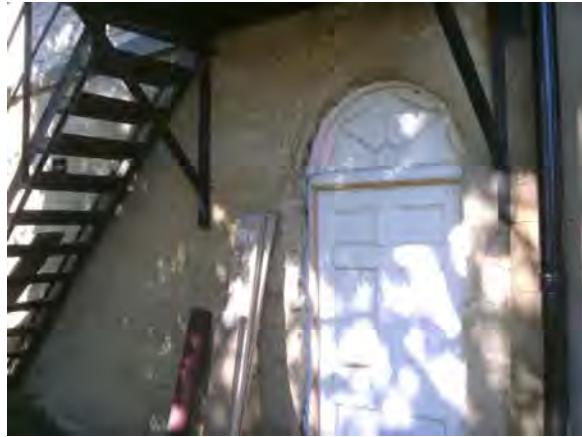
The lower section of the function room is of calcareous sandstone ashlar in a generally sound condition. It has never been repointed with OPC mortar. Some repointing is required.

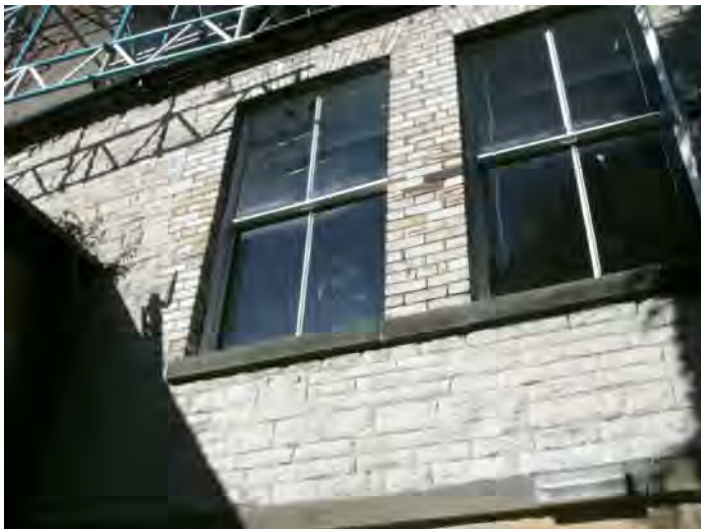
The upper wall of the function room is of white brick rising from a West Yorks sandstone string-course and requires little repointing at this time. The cills are of West Yorks sandstone. The Pennine sandstone details will be contemporary with the brickwork.

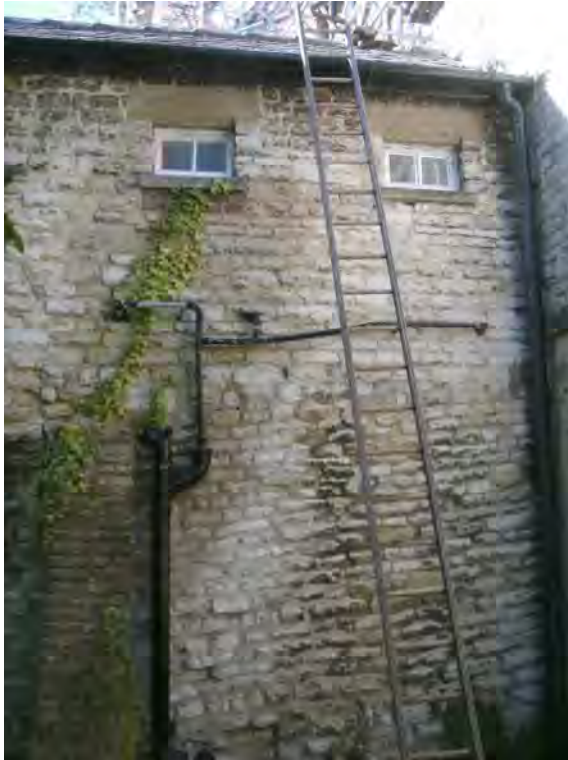
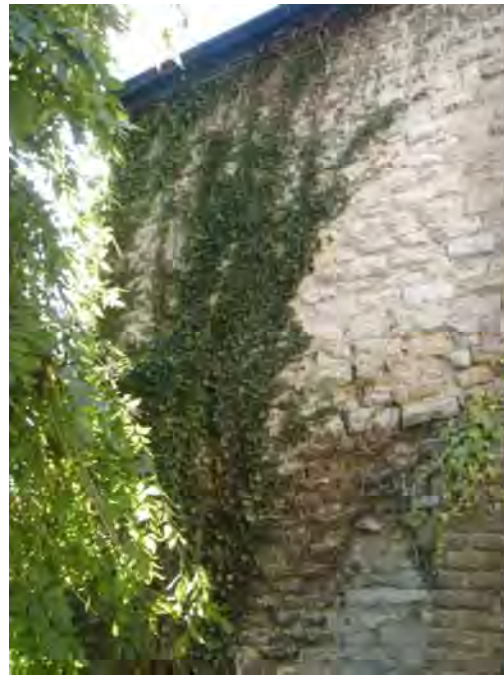
The western boundary of the Cloisters terrace is framed by a high, Hildenley and oolitic limestone wall that runs on the line of the medieval town wall. The lower levels are of Hildenley limestone and form part of the earlier C17 garden wall that continues away from this building to the south. The upper level is of Malton oolite and forms the east wall of the toilet block added in 1886, the southern and western walls of which are of brick. There is a later brick buttress to the lower, earlier section of wall. There are two small windows at high level beneath North York Moors sandstone

lintels. There is some localised decay of the stonework and some opc repointing. These areas should be repointed and mortar repaired with lime mortar.
